Aviation Accident Review

FY04

Department of the Interior Aviation Accident Review

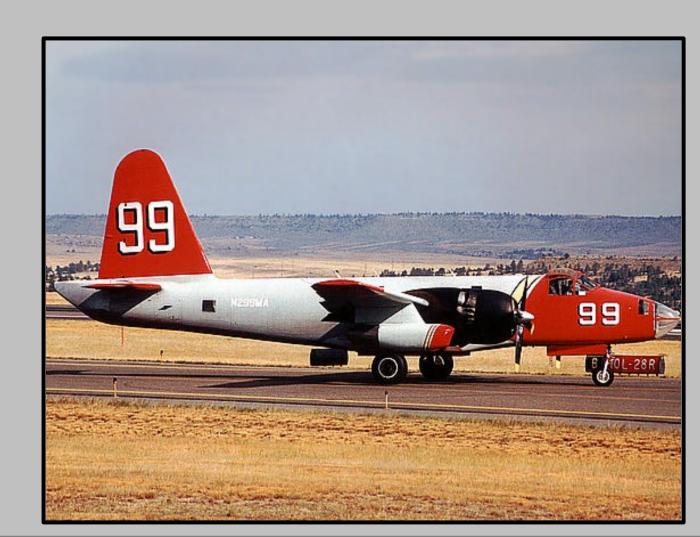
East Highlands, CA October 3, 2003

The P2V was observed flying up the Santa Ana Canyon from the southwest to the northeast. The aircraft made a 180° left turn, and descended into the clouds on a southwesterly heading towards the San Bernardino Airport / Air Tanker Base.

Moments after entering the clouds the witnesses observed a "rapidly rising dome" in the cloud deck.

The aircraft was destroyed when it impacted terrain.

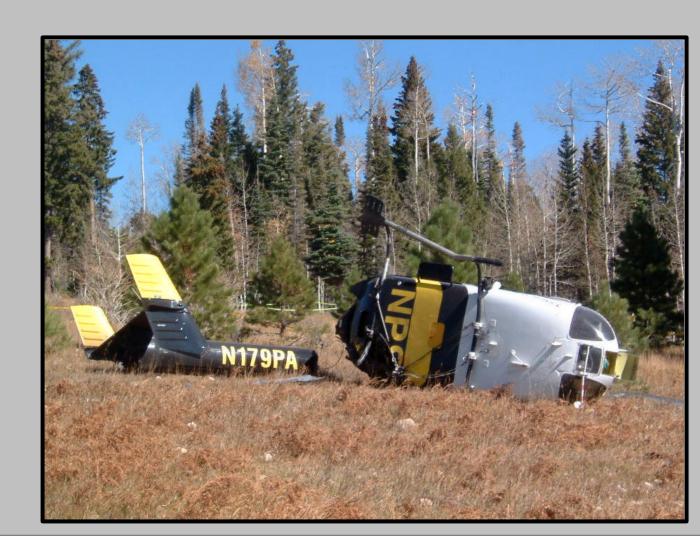
Fredonia, AZ October 16, 2003

During approach to a helispot at approximately 40 feet above ground level and 10 knots the aircraft began a sudden uncommanded right yaw.

The pilot reported the pedals feeling unresponsive, as if they were disconnected.

The aircraft made several revolutions and impacted on its skids before coming to rest on its left side.

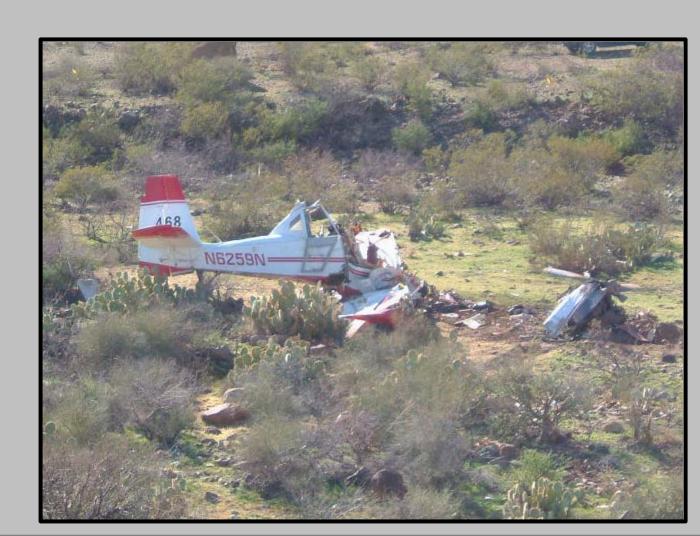
Safford, AZ March 16, 2004

On the base leg to a simulated fire, witnesses heard the engine "surge" 2-3 times and observed the aircraft in an unusual attitude with its "right wing high and its nose low."

The evidence at the site indicates that the aircraft impacted the ground in a nearly vertical attitude.

The aircraft was destroyed and the pilot received fatal injuries.

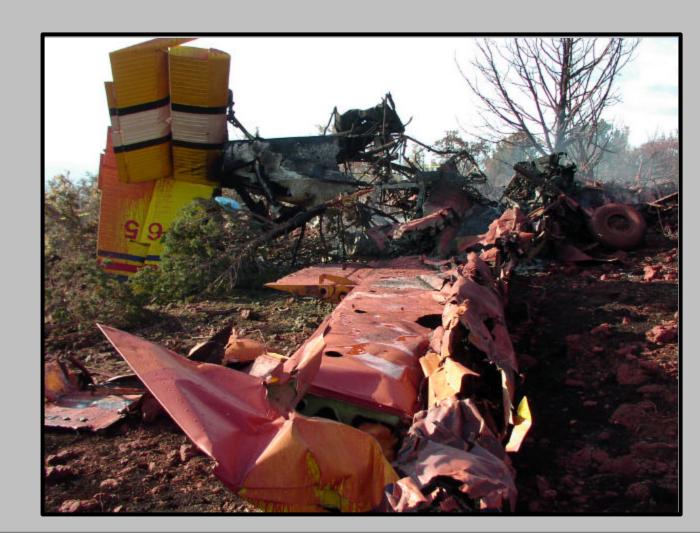
St. George, UT June 17, 2004

During a fire retardant mission the pilot was observed to make an early drop followed by the aircraft's nose pitching down approximately 45°.

The aircraft impacted the ground in a nearly vertical attitude and exploded.

The aircraft was destroyed and the pilot received fatal injuries.

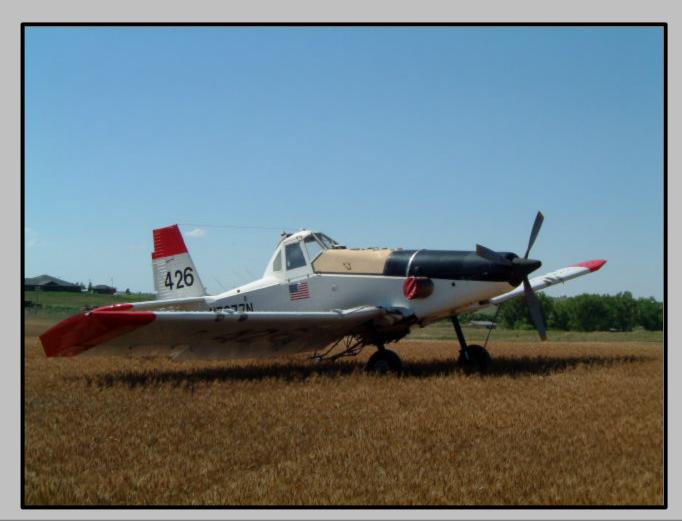
Pine Ridge, SD July 11, 2004

While preparing to enter the traffic pattern for landing, the pilot noticed the N2 (prop RPM) overspeed light illuminate.

The pilot tried, but was unable, to maintain prop RPM without the engine overspeeding.

The pilot reduced power to control the engine RPM and made an off-airport landing.

The propeller went to an overspeed condition as a result of contamination of the propeller control unit due to improper servicing by the operator and the mechanic.

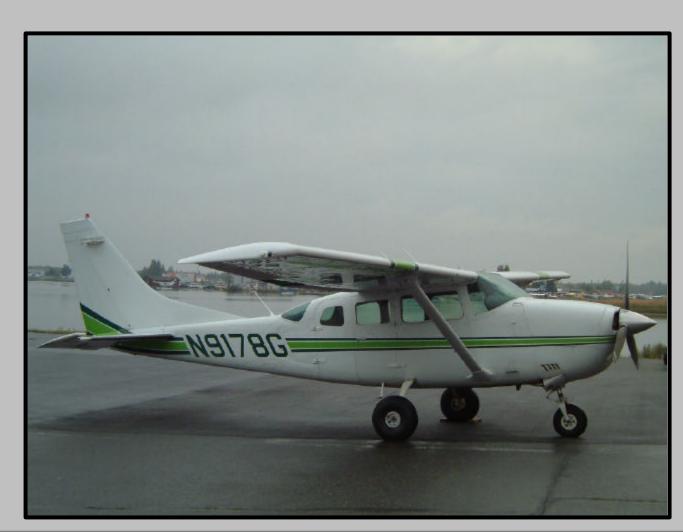
Yakutat, AK July, 2004

During the takeoff roll the aft cargo door opened and slammed into the fuselage.

The pilot aborted the takeoff, inspected the door for damage, and then resumed the flight.

The aircraft was flown several more times before the damage was reported via SAFECOM.

- The pilot's inadequate preflight inspection, and his failure to secure the cargo door, which resulted in the cargo door coming open during the takeoff roll.
